Shire of Menzies

Damage Assessment and Scope of Works Report

AGRN962 Storm, Heavy Rain and associated Flooding in the Midwest and Southwest Land Division (1 - 5 March, 2021).

Cost Estimate Rev 0.0 Version 7 – Report Version 1

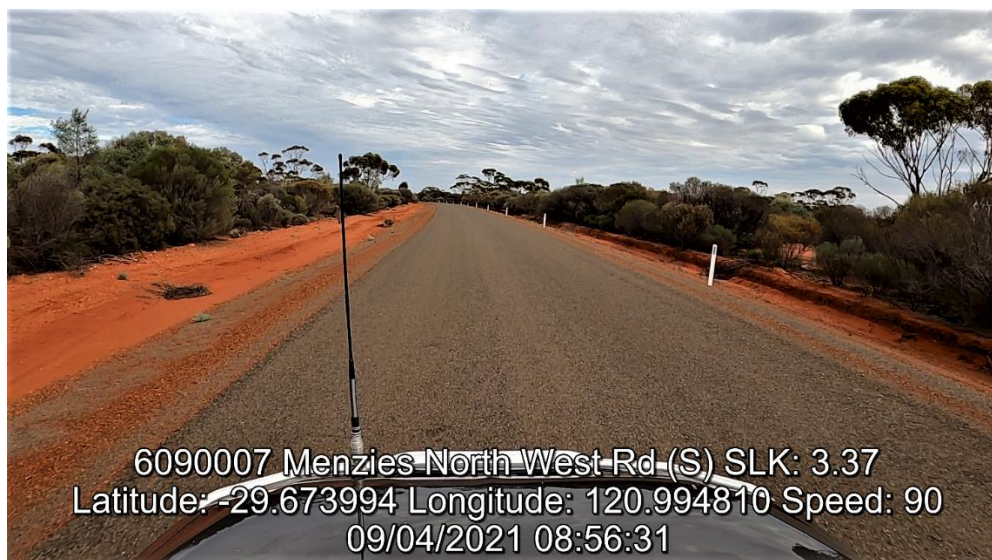
SLK 0 -10

Post Damage Photo (After, Photo 4)

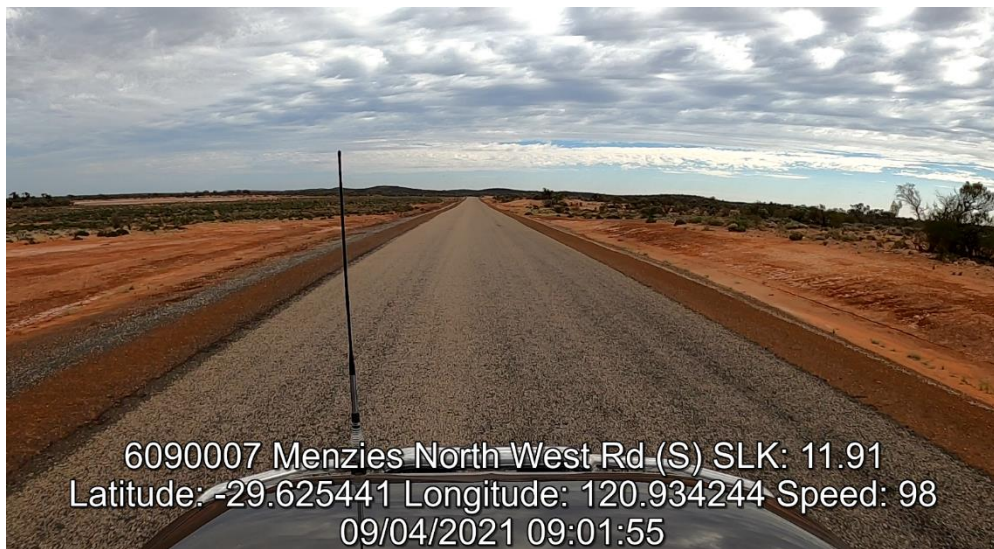
SLK 10 - 20

Post Damage Photo (After, Photo 24)

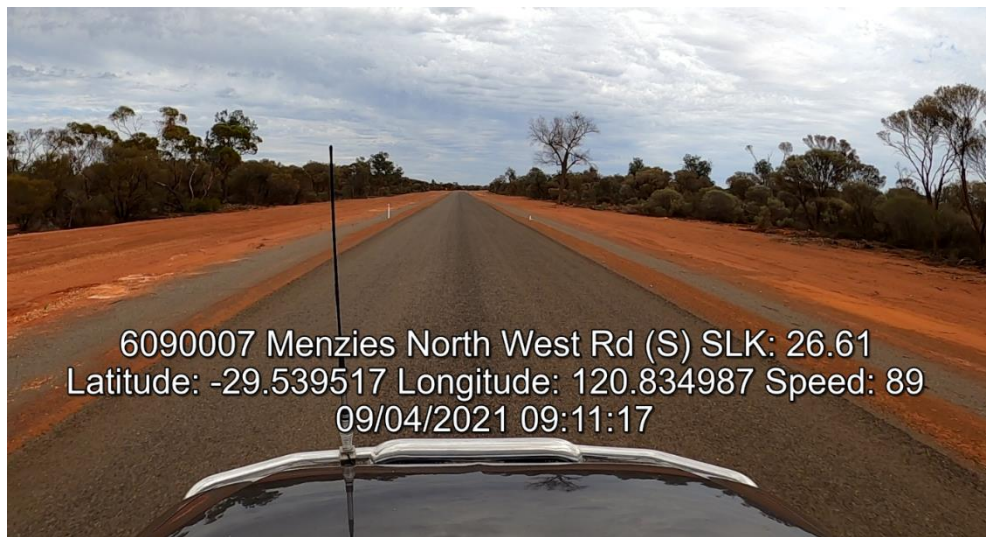
SLK 20 - 30

Post Damage Photo (After, Photo 68)

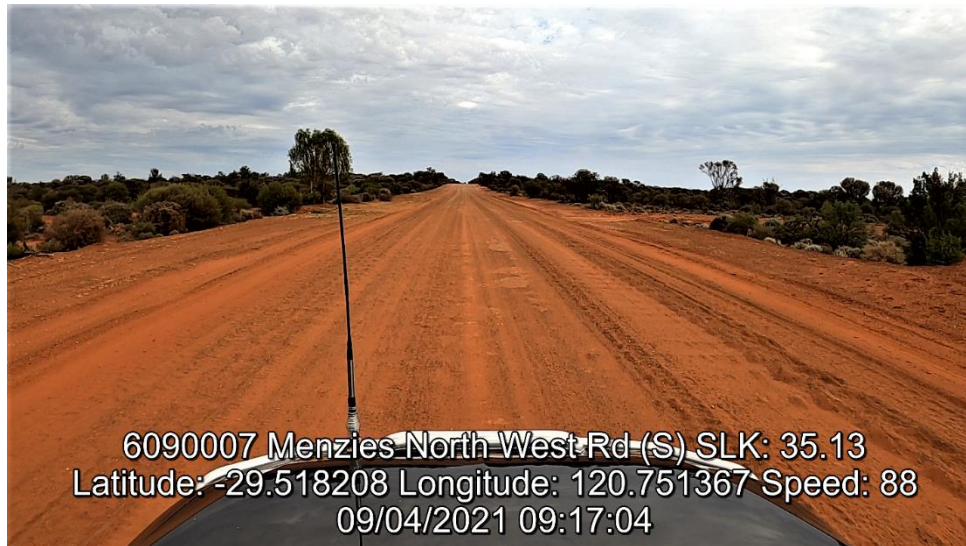
SLK 30 - 40

Post Damage Photo (After, Photo 84)

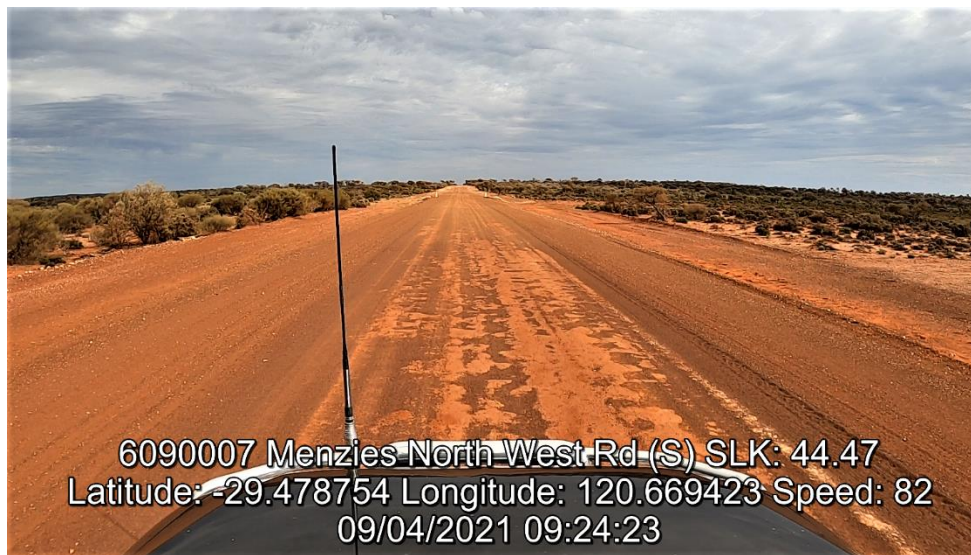
SLK 40 - 50

Post Damage Photo (After, Photo 109)

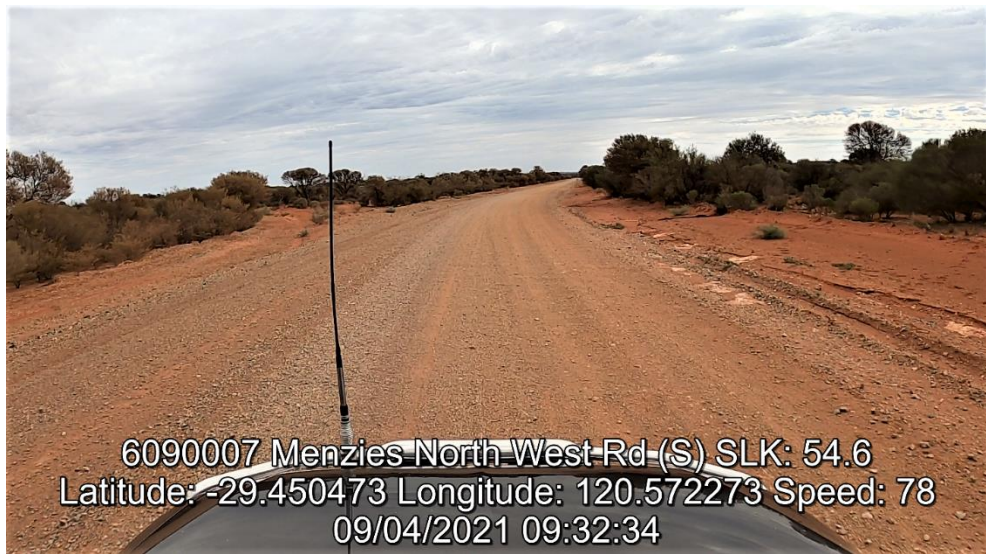
SLK 50 - 60

Post Damage Photo (After, Photo 130)

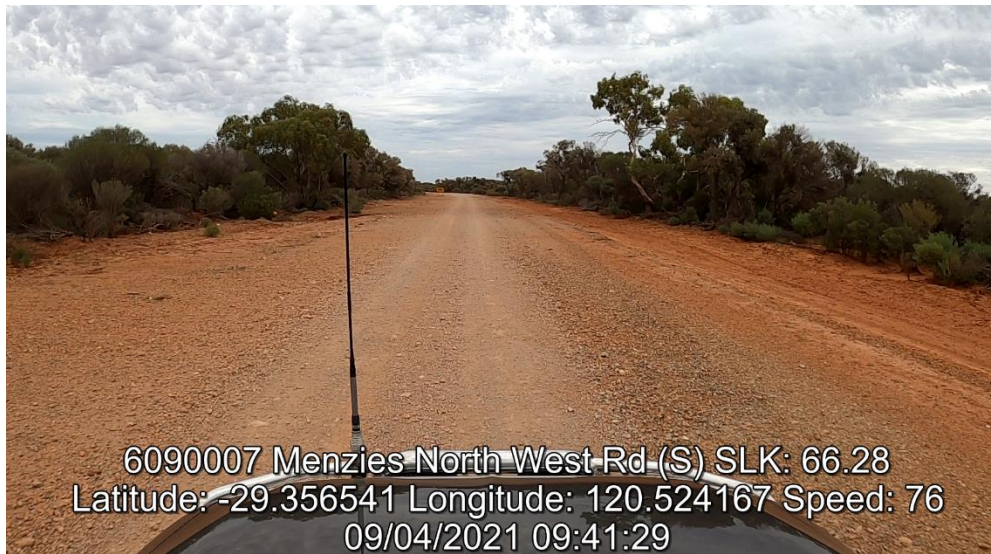
SLK 60 - 70

Post Damage Photo (After Photo 165)

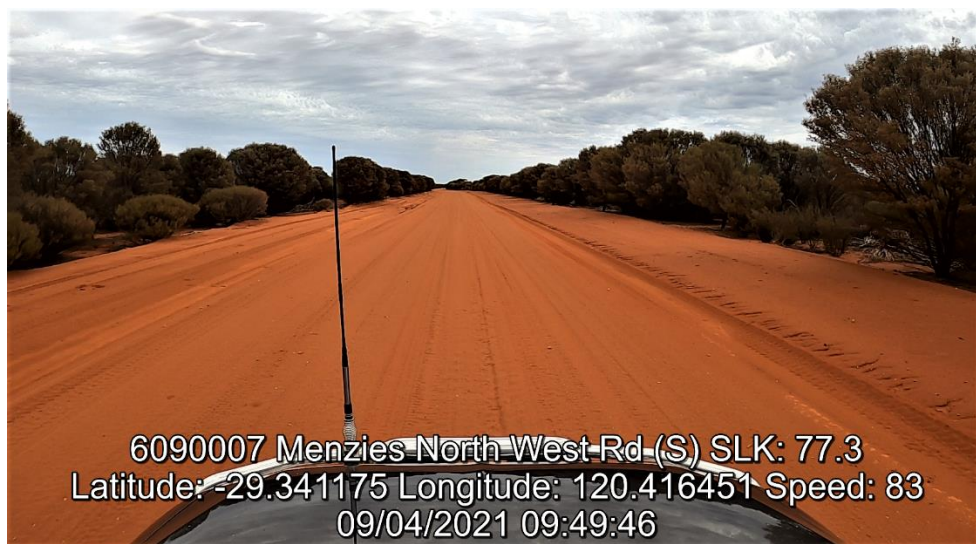
SLK 70 - 80

Post Damage Photo (After Photo 178)

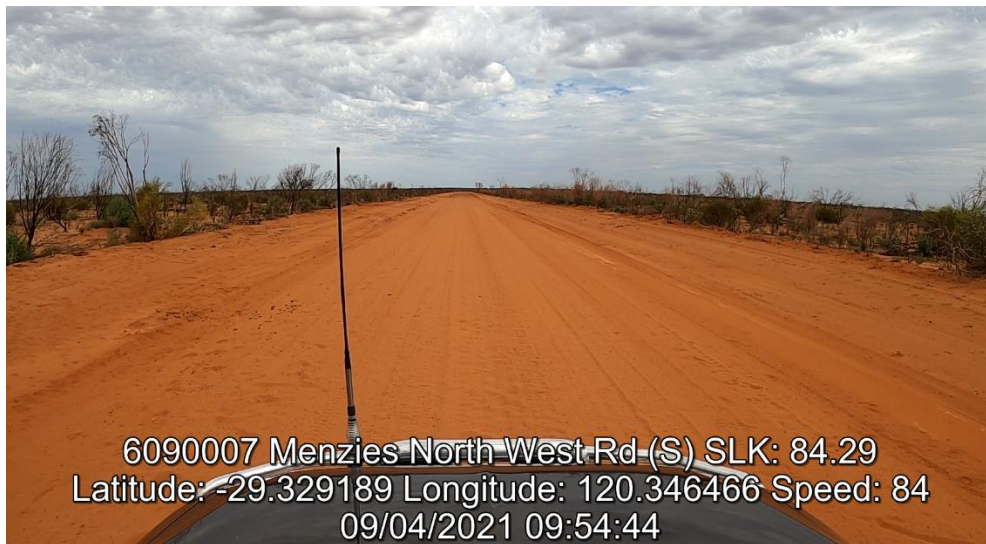
SLK 80 - 90

Post Damage Photo (After Photo 184)

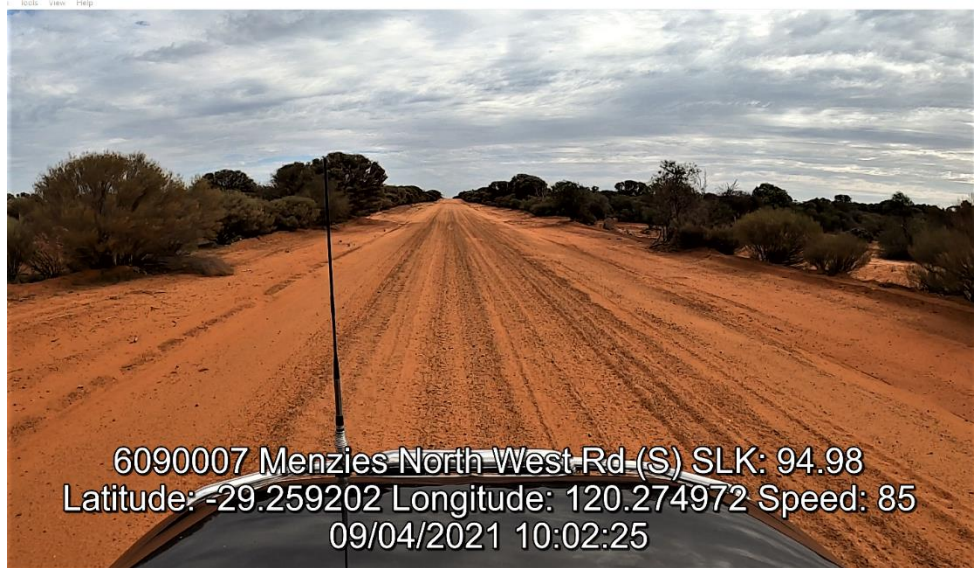
SLK 90 - 100

Post Damage Photo (After Photo 204)

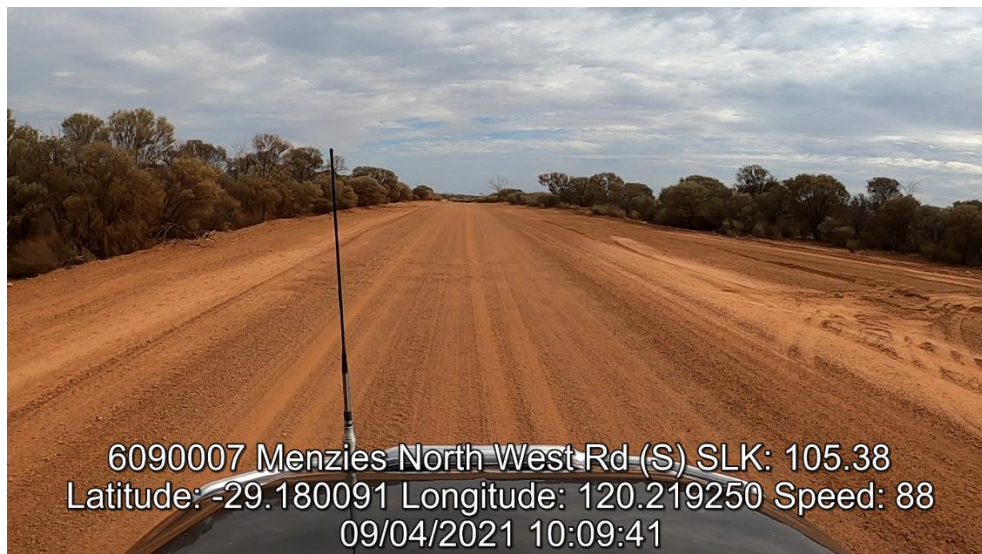
SLK 100 - 110

Post Damage Photo (After Photo 235)

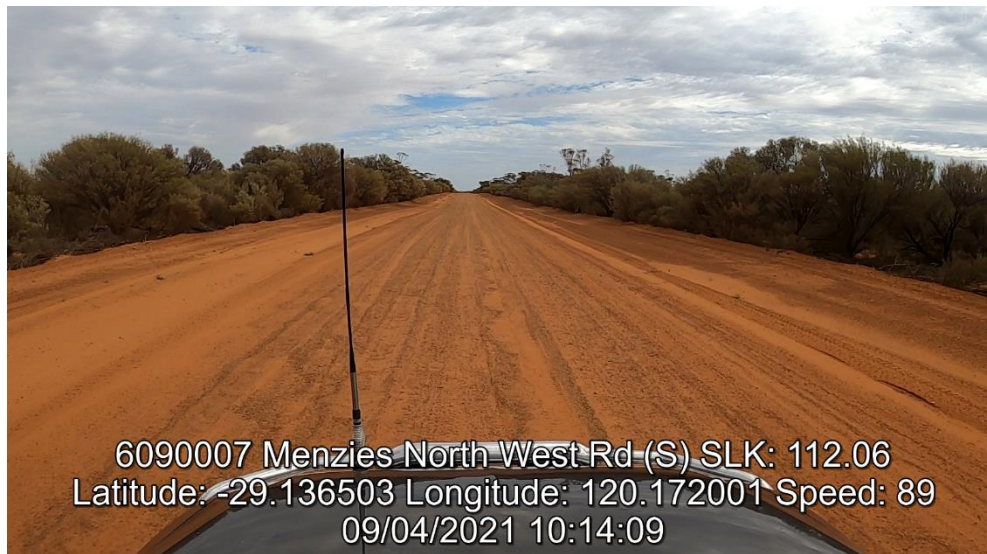
SLK 110 - 120

Post Damage Photo (After Photo 247)

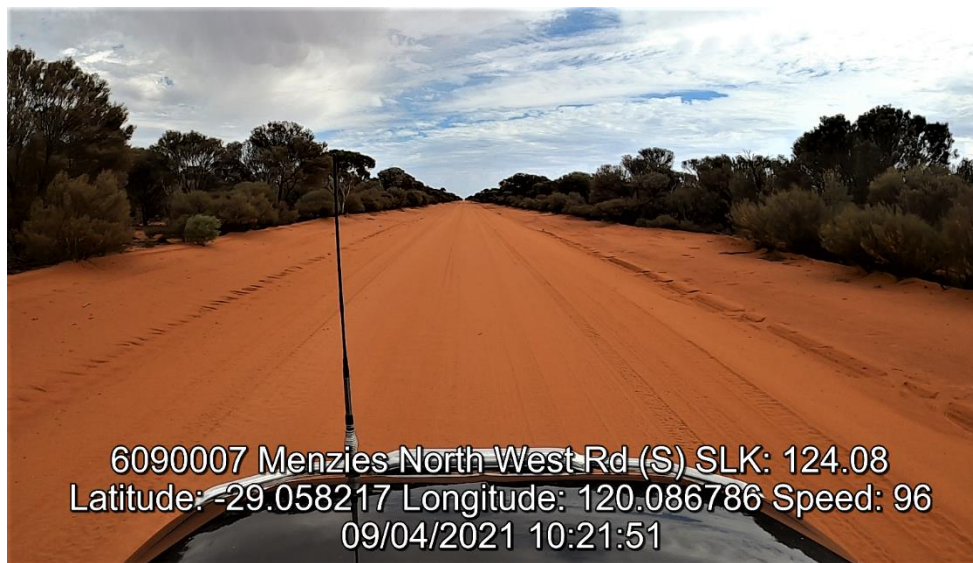
SLK 120 - 130

Post Damage Photo (After Photo 258)

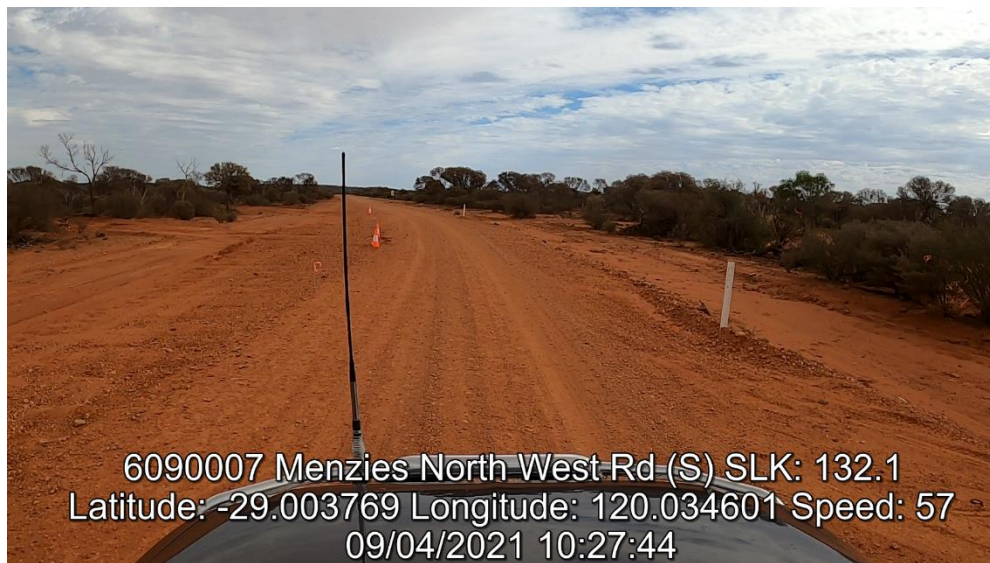
SLK 130 - 140

Post Damage Photo (After Photo 285)

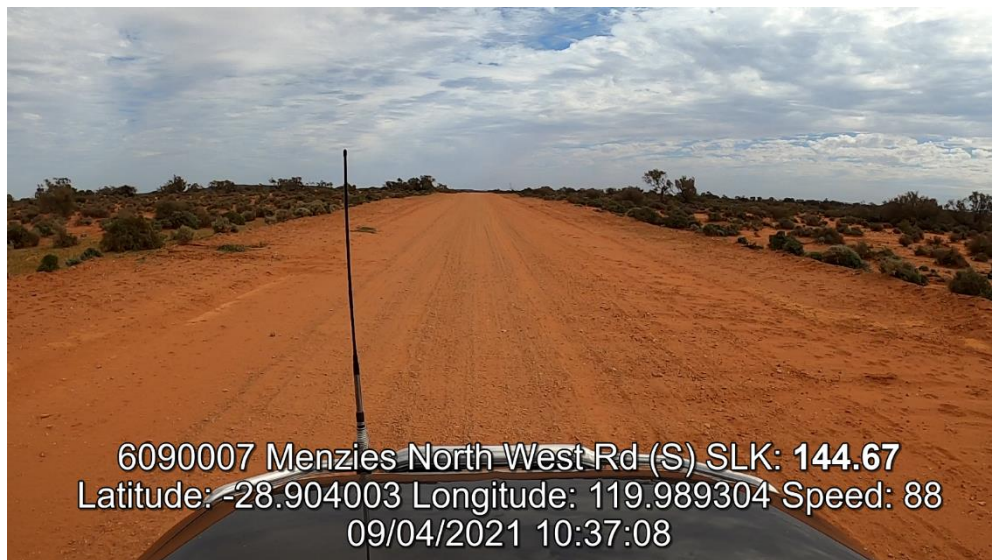
SLK 140 - 150

Post Damage Photo (After Photo 326)

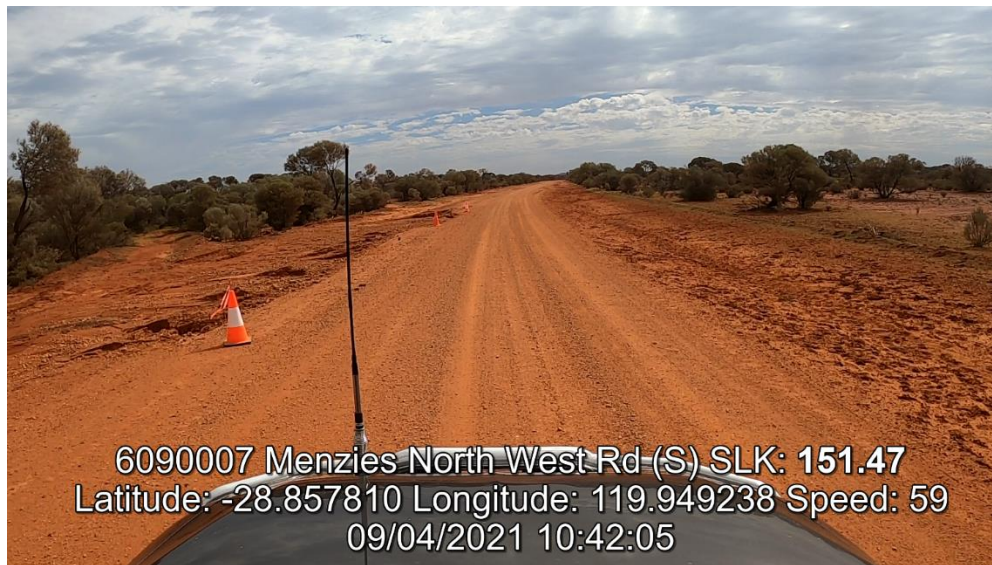
SLK 150 - 160

Post Damage Photo (After Photo 349)

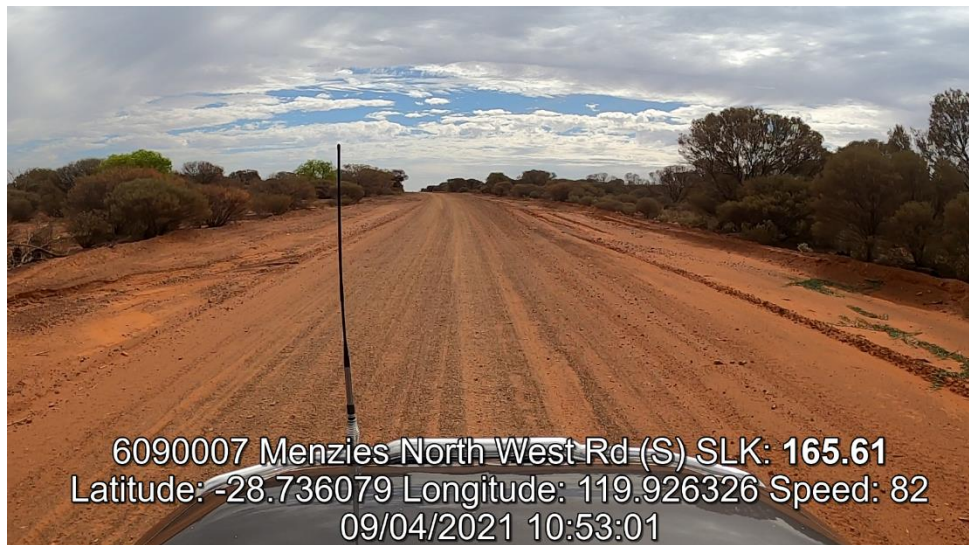
SLK 160 - 170

Post Damage Photo (After Photo 406)

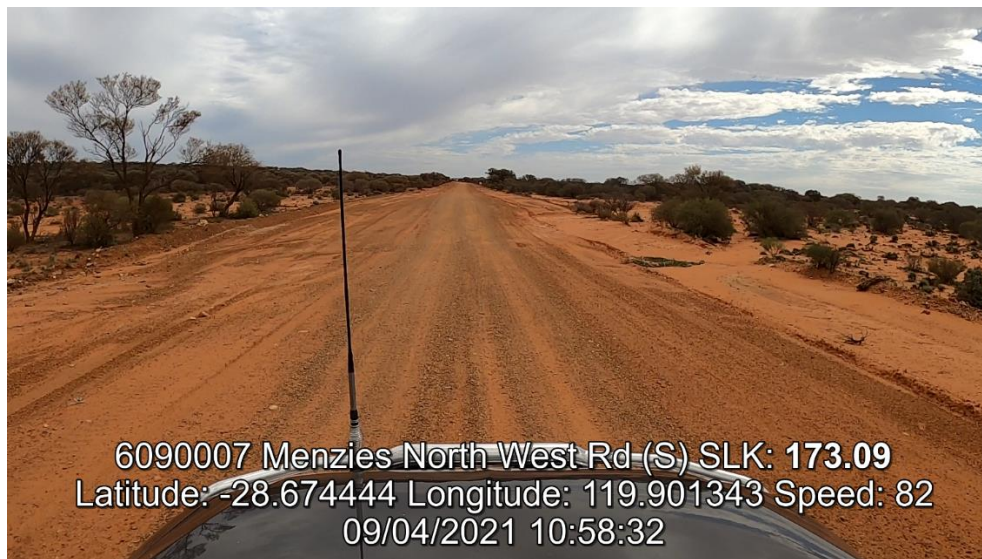
SLK 170 - 180

Post Damage Photo (After Photo 421)

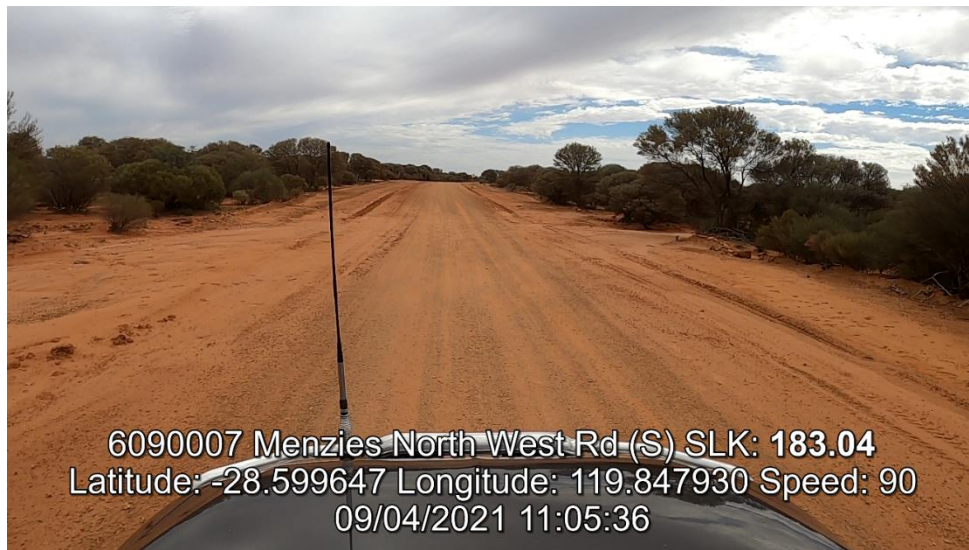
SLK 180 - 190

Post Damage Photo (After Photo 430)

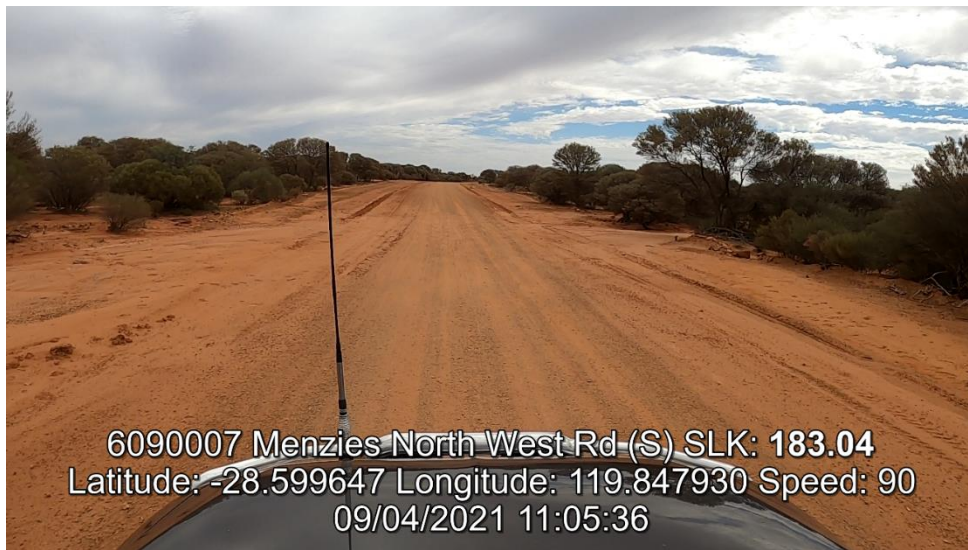
SLK 180 - 190

Post Damage Photo (After Photo 430)

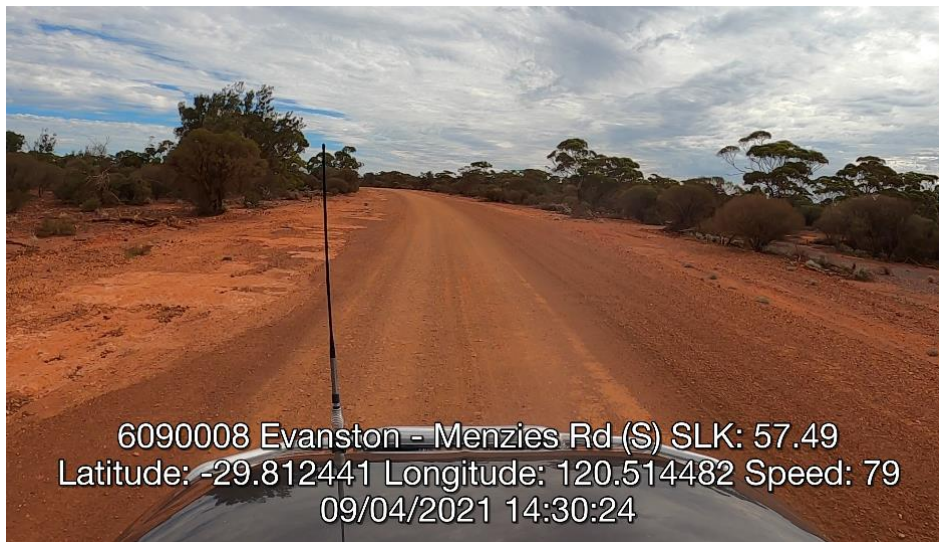
SLK 50 - 60

Post Damage Photo (After Photo 2)

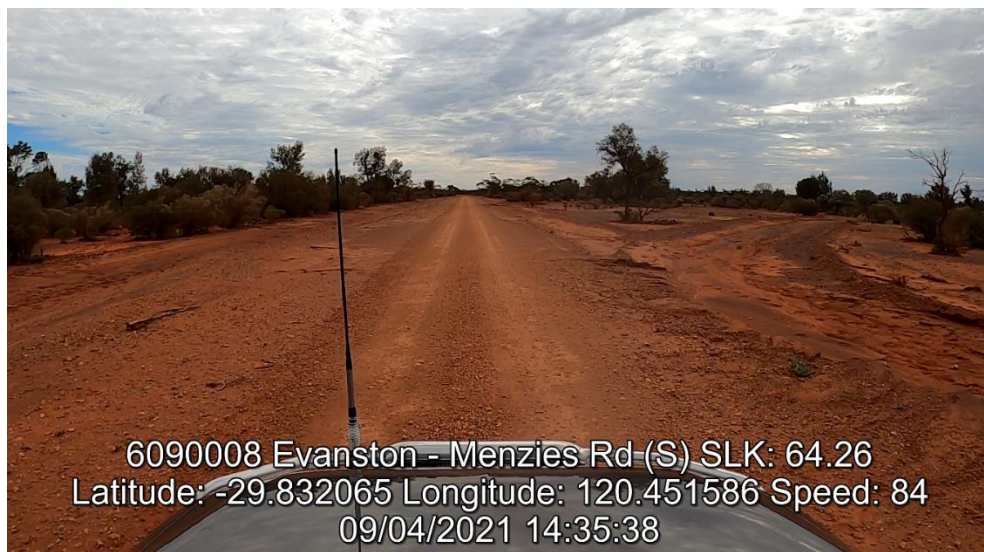
SLK 60 - 70

Post Damage Photo (After Photo 18)

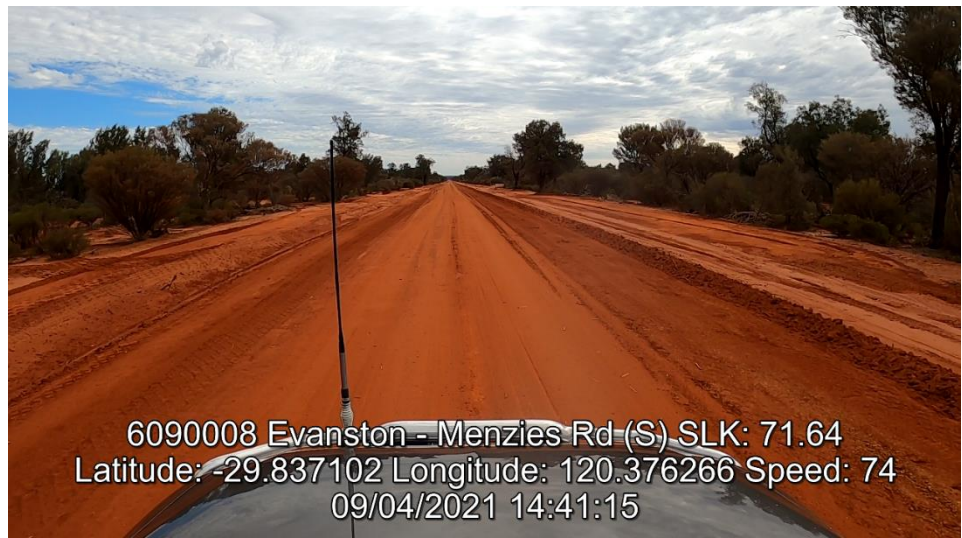
SLK 70 - 80

**Post Damage Photo (After Photo 31)
NB: Reinstatement works underway**

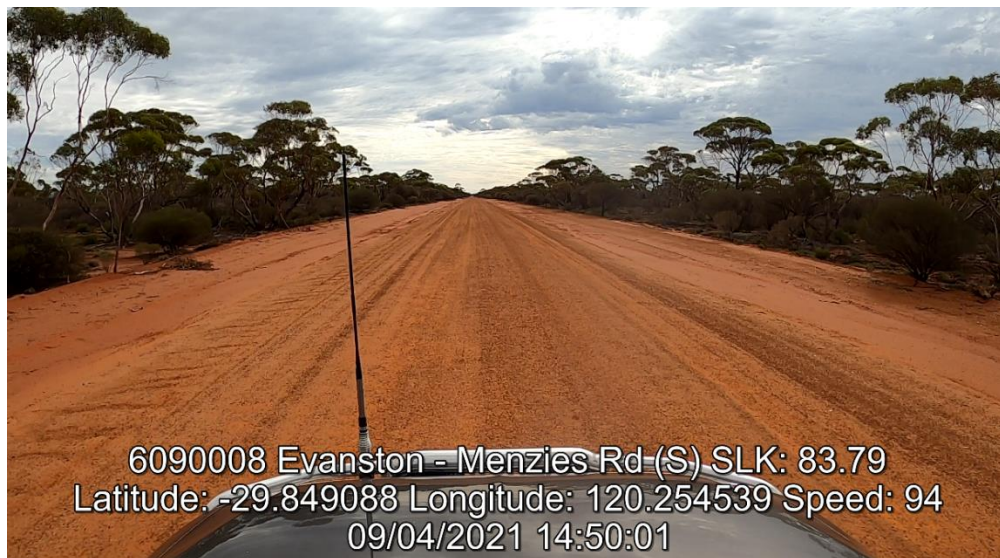
SLK 80 - 90

Post Damage Photo (After Photo 38)

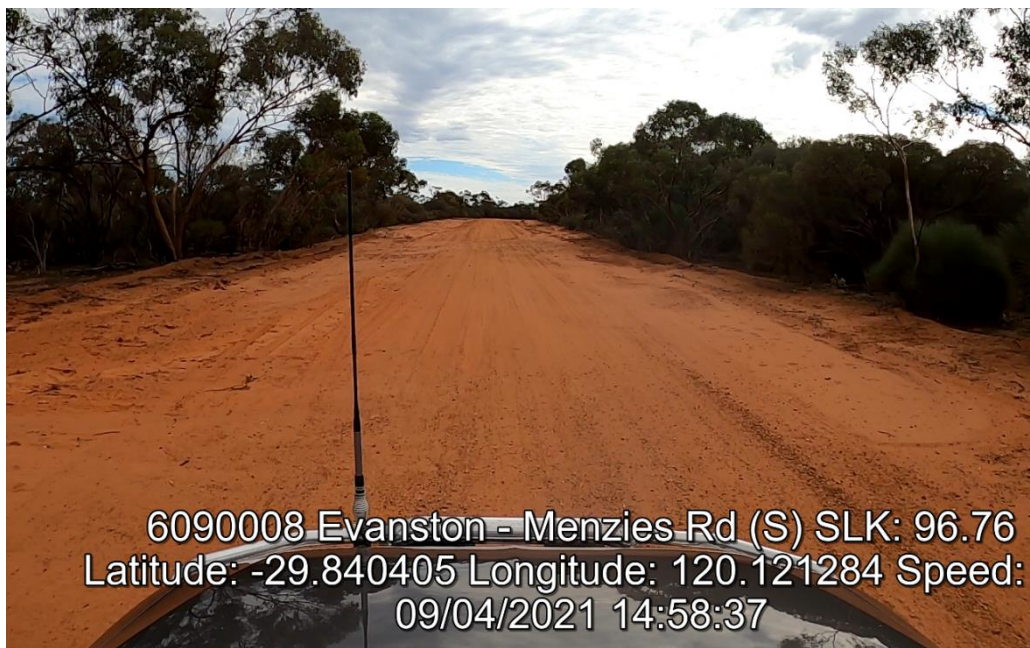
SLK 90 - 100

Post Damage Photo (After Photo 53)

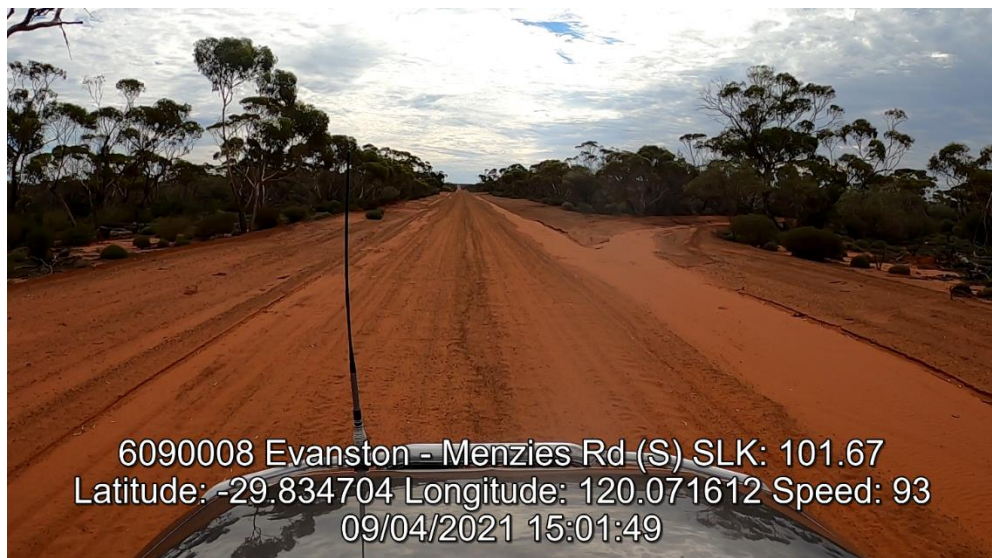
SLK 100 - 110

Post Damage Photo (After Photo 60)

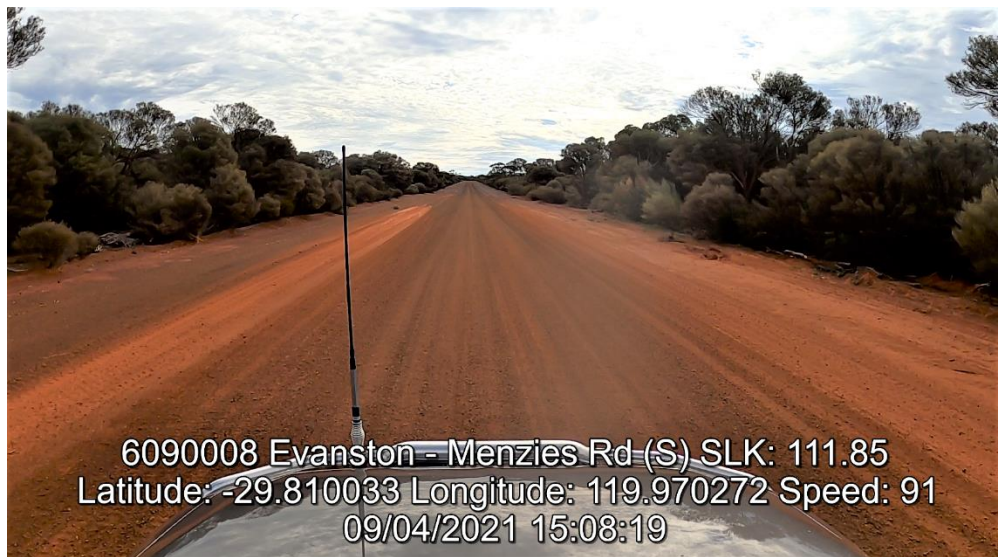
SLK 110 - 120

Post Damage Photo (After Photo 71)

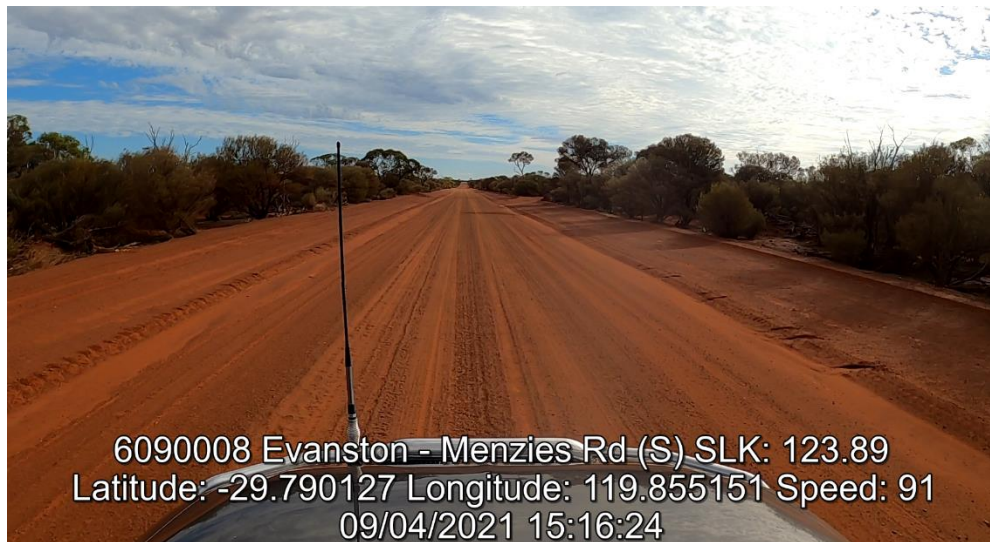
SLK 120 - 130

Post Damage Photo (After Photo 76)

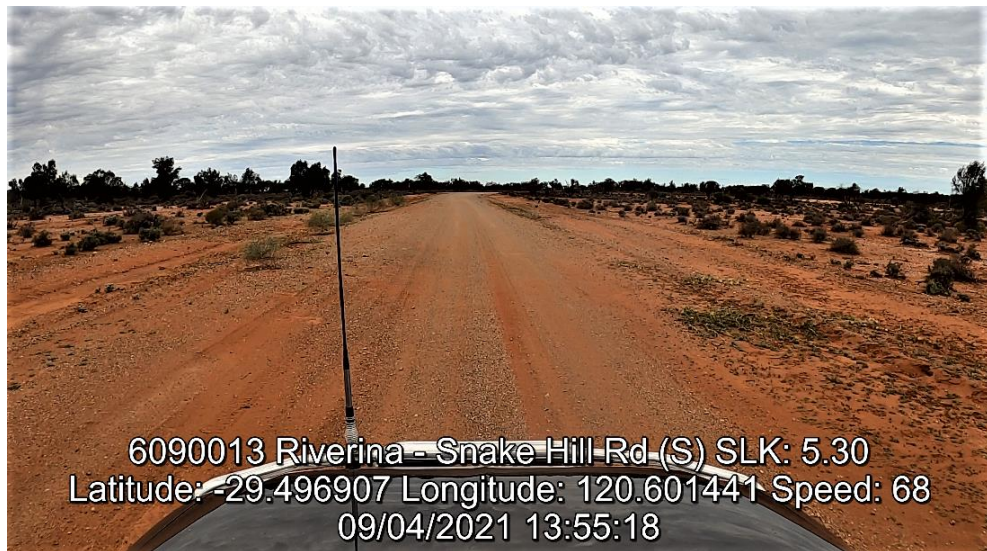
SLK 0 - 10

Post Damage Photo (After Photo 16)

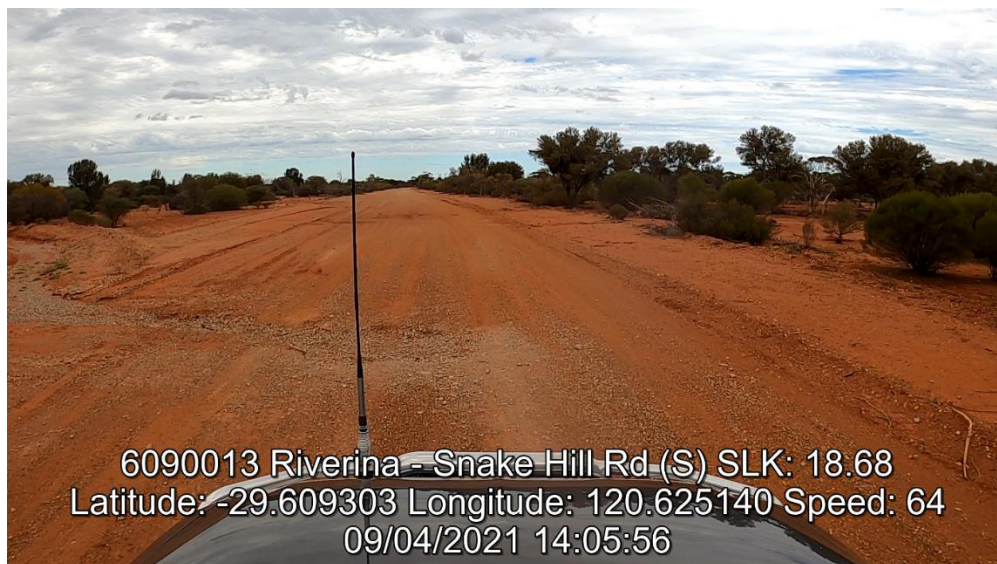
SLK 10 - 20

Post Damage Photo (After Photo 39)

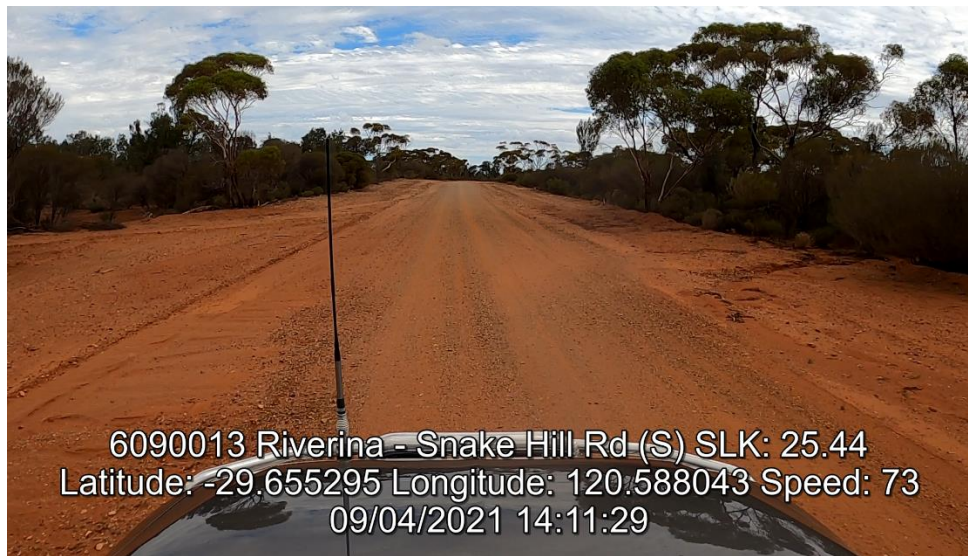
SLK 20 - 30

Post Damage Photo (After Photo 76)

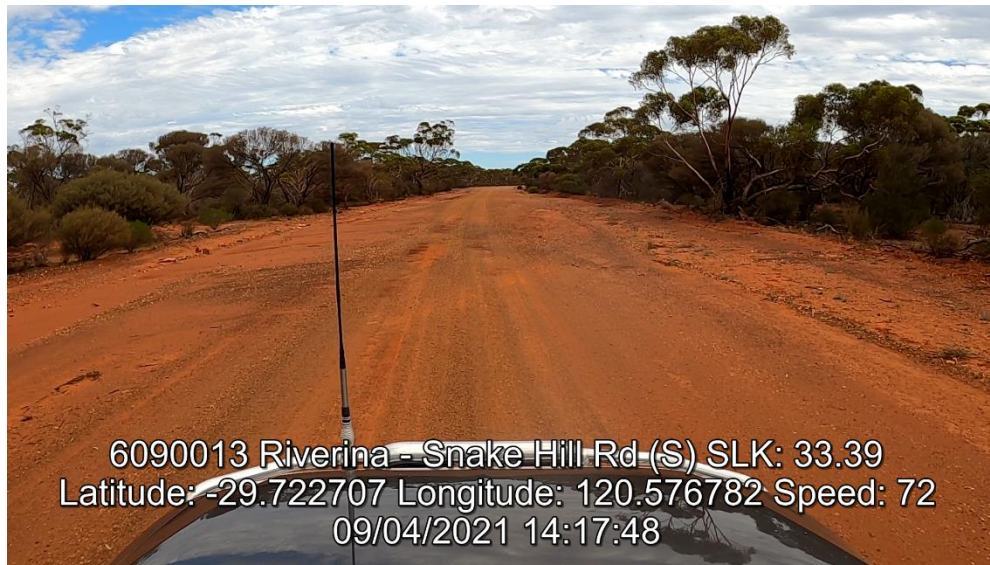
SLK 30 - 40

Post Damage Photo (After Photo 76)
